# U. S. DEPT. OF THE INTERIOR

### Mine Site Evaluation

**Emery Deep Complete Joint Inspection**

Utah Permit ID #C-015-0015

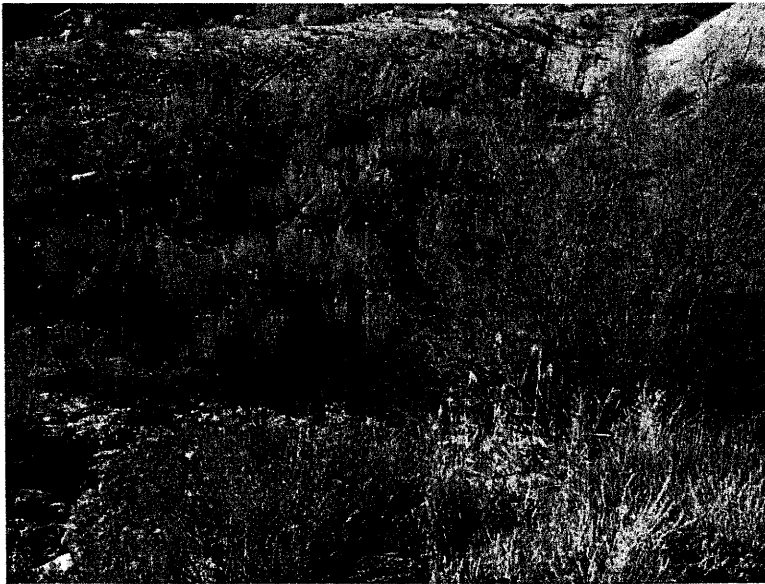
**Field evaluation:** Drainage from the old facilities area near the office reports to sediment ponds 3 and 8. Both ponds were dry at the time of inspection. Pond 3 has an old piece of pipe on the embankment which Jaren was notified should be properly removed and disposed of (see Figure 1).

Figure 1: Pond 3 with pipe needing to be removed

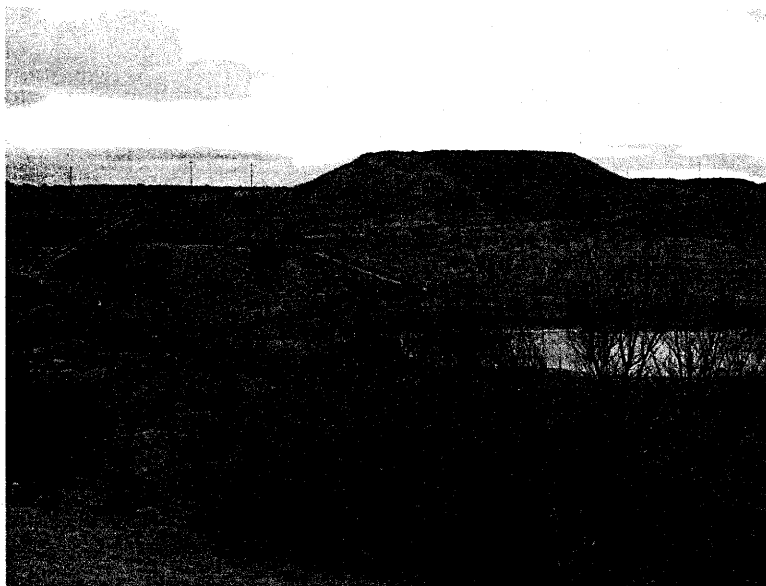
Pond 5 was containing water at the time of inspection. An inlet culvert is cracked and should be repaired / replaced (see Figure 2). Jaren was notified.

Figure 2: Pond 5 with inlet culvert needing repair
